# Out-of-Plane Strengthening of Unreinforced Masonry Walls with Openings

A. Ghobarah<sup>1</sup> and K. El Mandooh Galal<sup>2</sup>

**DOI:** 10.1061/(ASCE)1090-0268(2004)8:4(298)

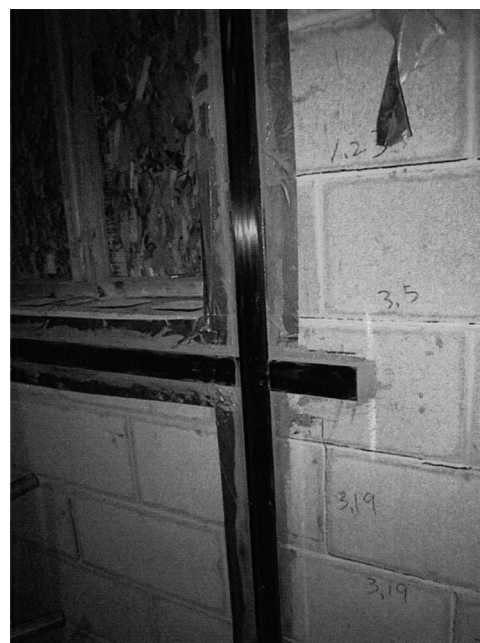
**Fig. 2.** Carbon fiber-reinforced polymer strips before removing the duct tape

Two to three hours after completing application of the CFRP strips, the side duct tape is removed with excess gel. After 1 day, the duct tape on the surface of the CFRP strips can be removed. This will leave the strengthened wall with an aesthetically good looking clean surface. Fig. 2 shows the carbon strips at the point at which they intersect before removing all the duct tape from the side of the strip.

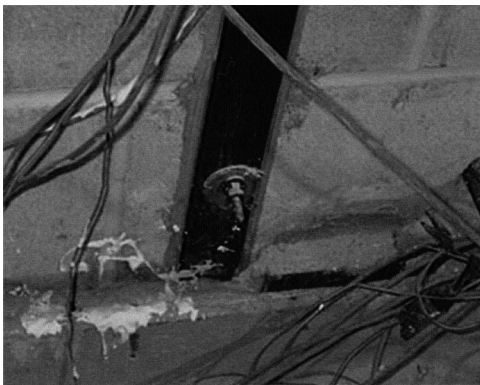
Fig. 4. Carbon strip anchored at bottom of wall

the anchoring system is shown in Fig. 3. Fig. 4 shows a typical anchor installed at the bottom end of the CFRP strip.

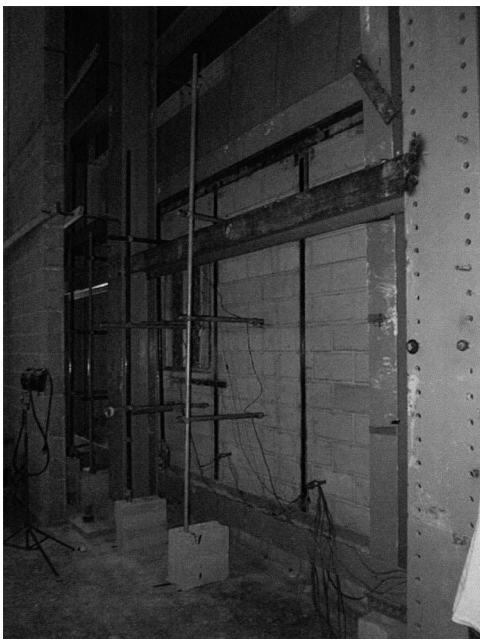
Fig. 5. Typical wall instrumentation

Each wall tested was instrumented with up to 16 linear variable differential transformers (LVDTs) to measure out-of-plane deflection, and by 13 10-mm strain gauges on the CFRP strips to measure strain. Deflections were measured at the CFRP strip location, between strips, and at the top and bottom of the wall opening. CFRP strains were measured at three locations along the strip length in order to provide a strain distribution profile. The airbag pressure was measured using two pressure gauge transducers, one at the air inlet and the other at the outlet. Data were recorded every 5 s using a computer controlled data acquisition system. Fig. 5 shows typical instrumentation of the wall. The walls were tested 2 weeks after application of the CFRP strips.
